**Safety Standards and Inspection Techniques  
For Natural Gas Composite Cylinders**

Craig Webster  
Powertech Labs Inc.

September 1999

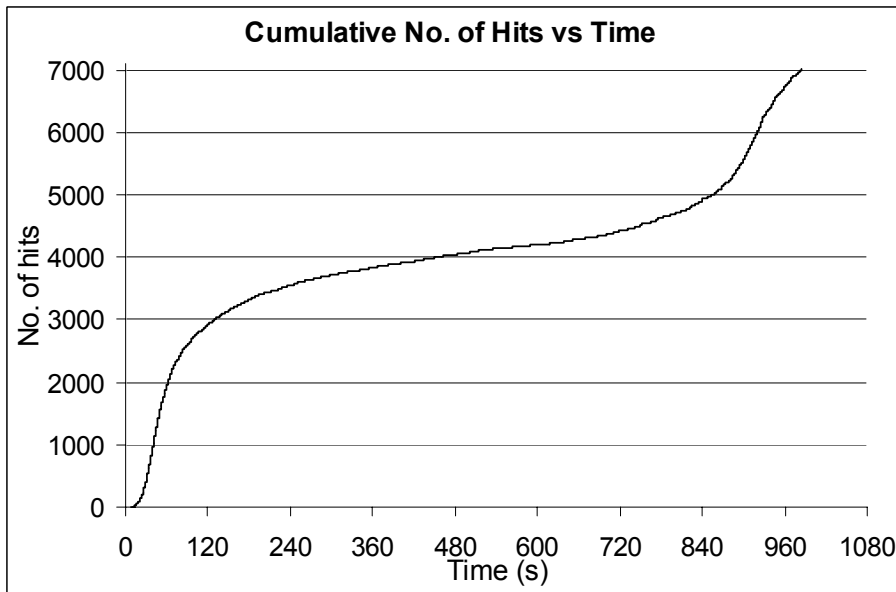
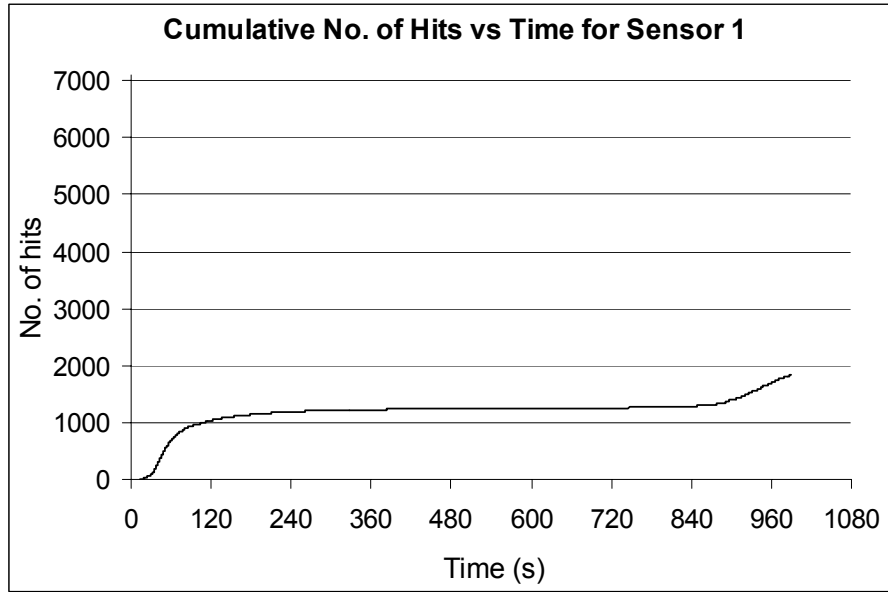
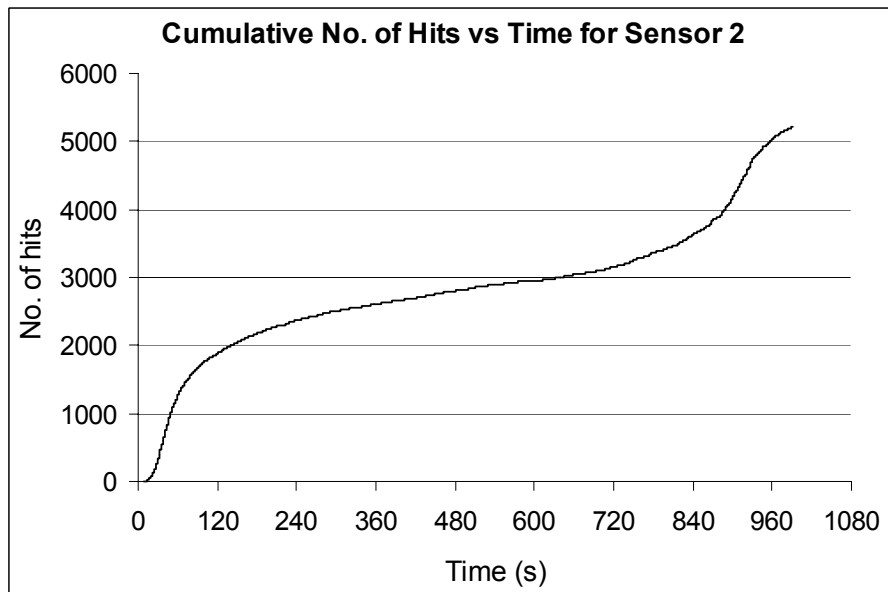
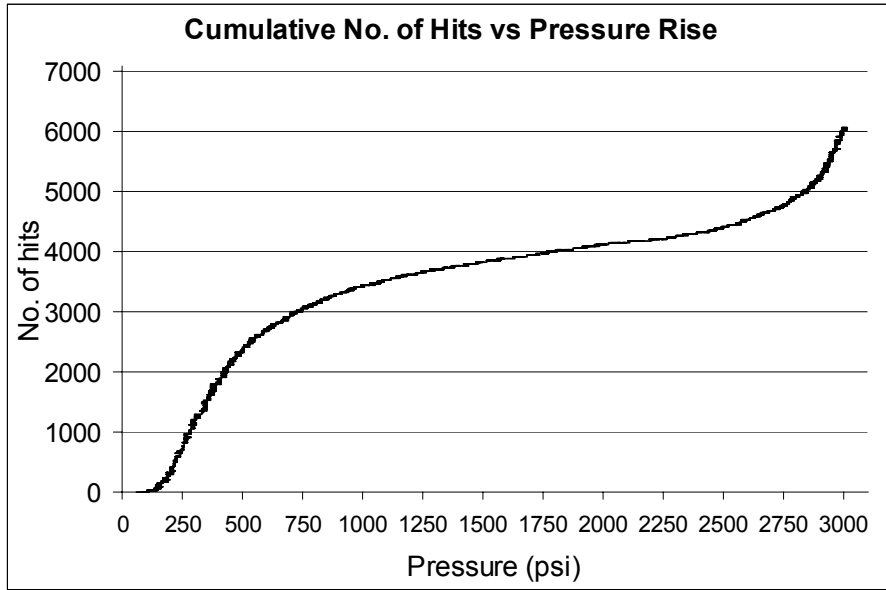
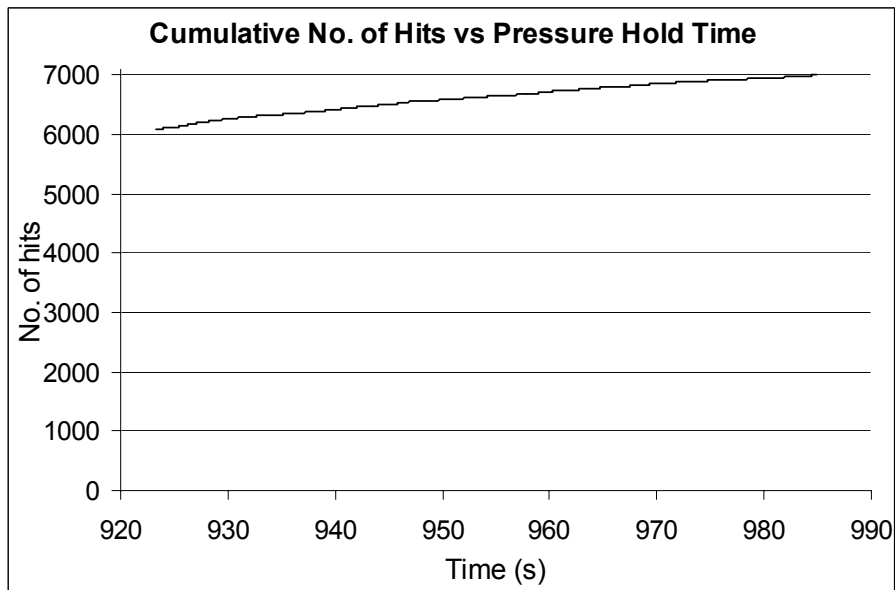
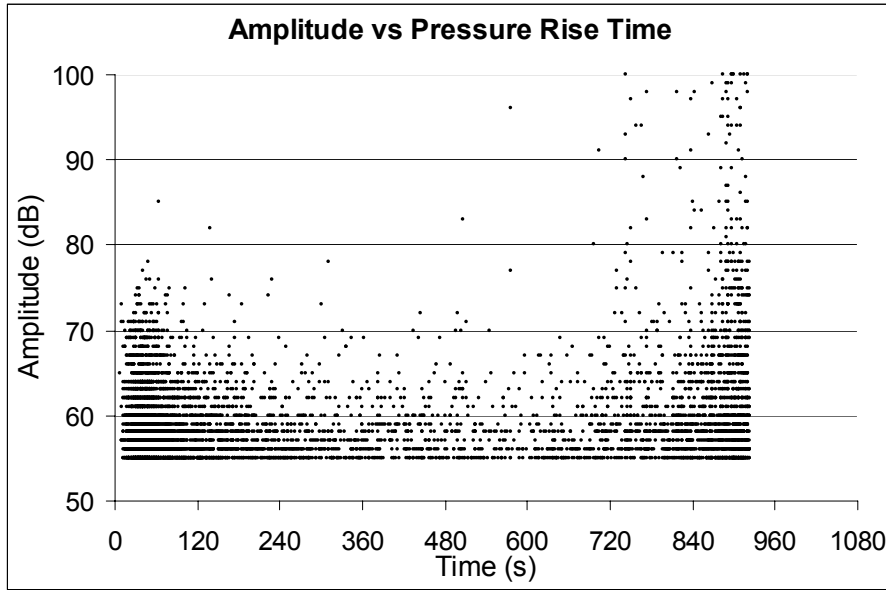
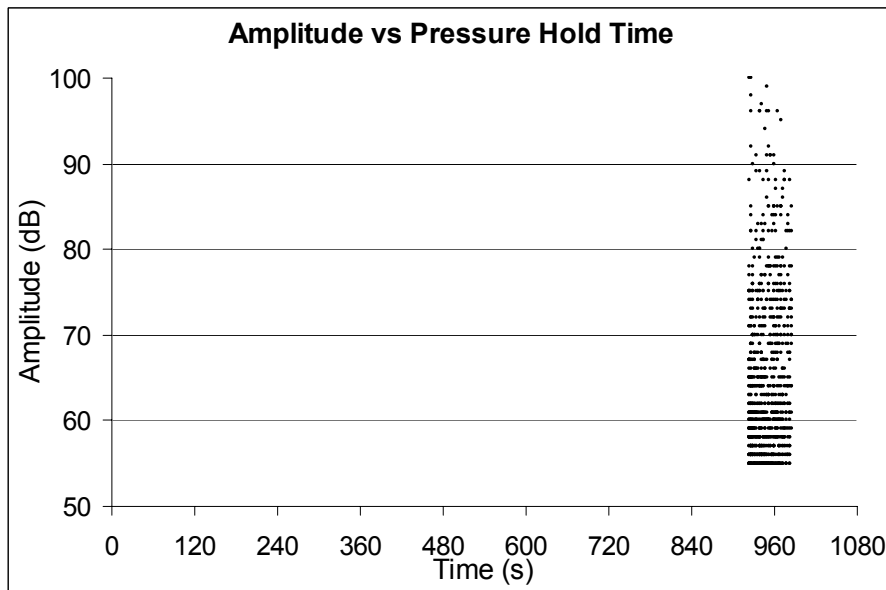
- **Second Inspection**

The results of the second test correspond to what could be expected, with fewer hits, but still characteristic of a damaged cylinder.

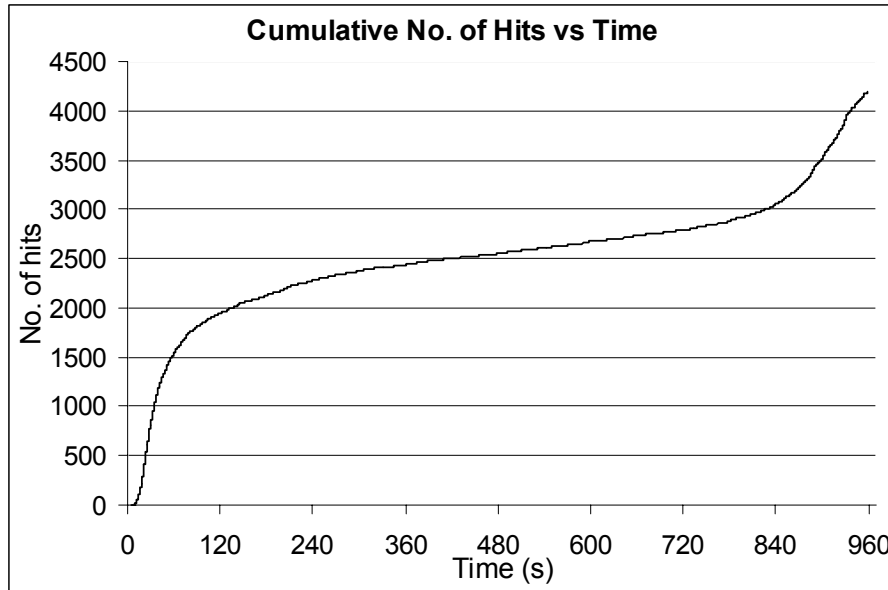
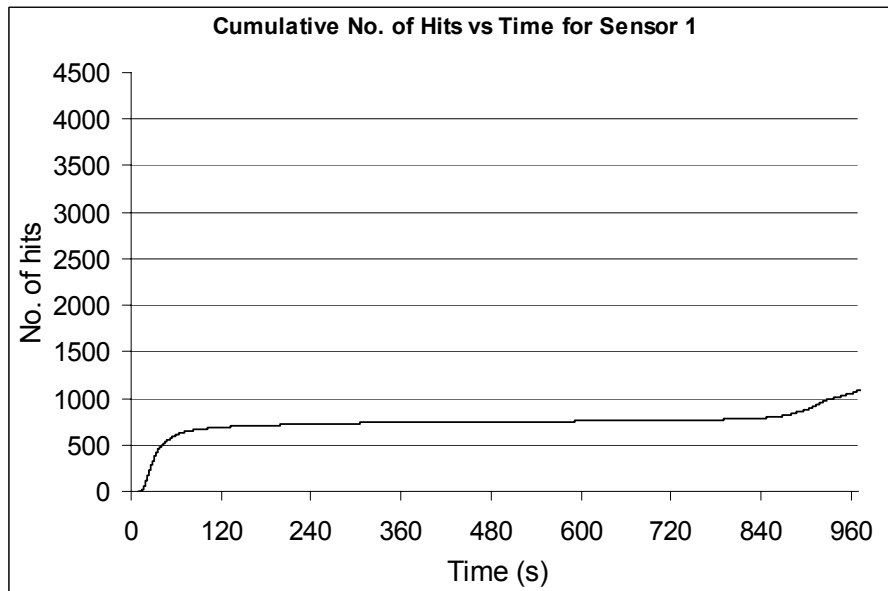
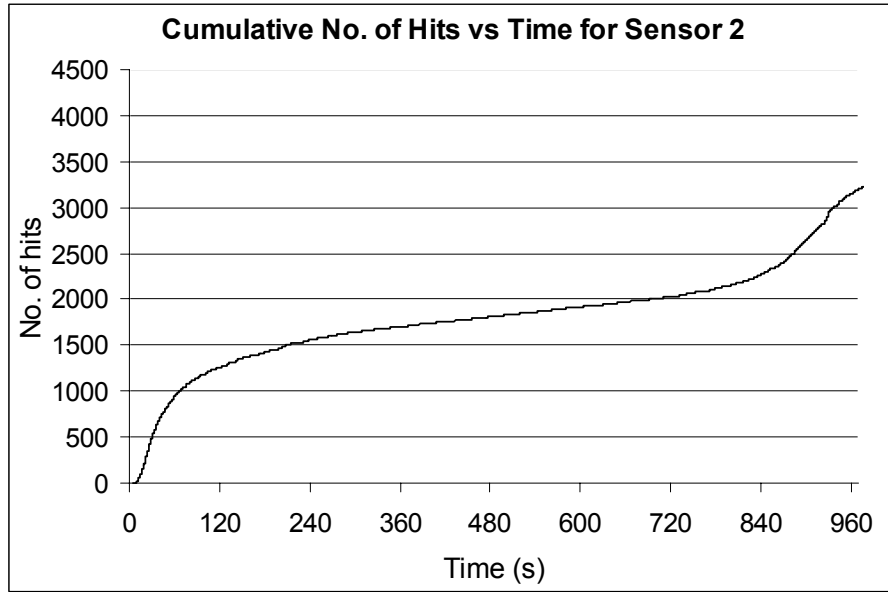
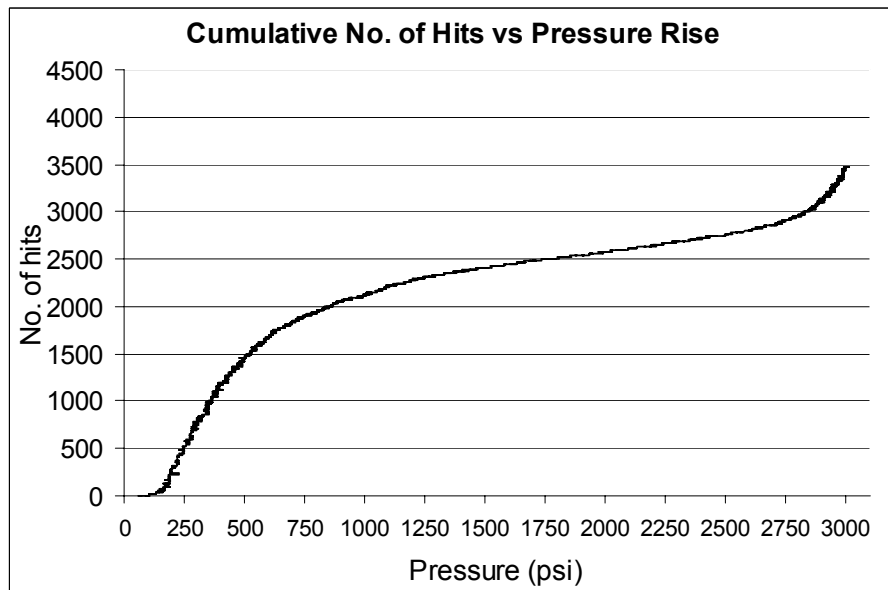
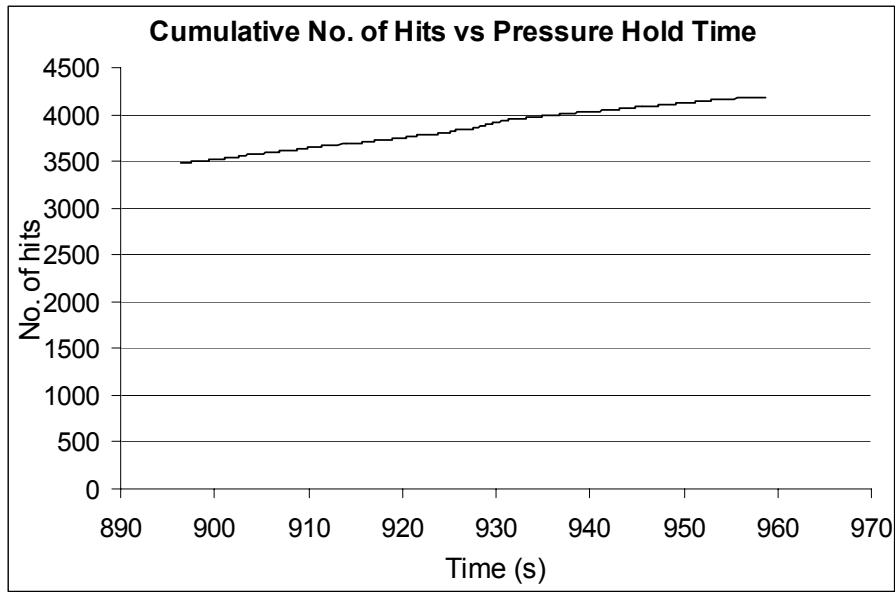
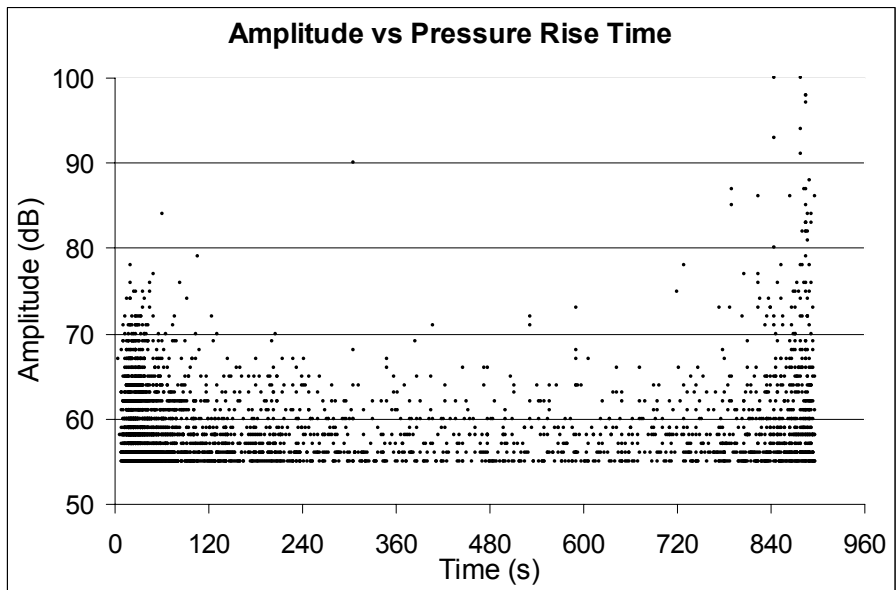
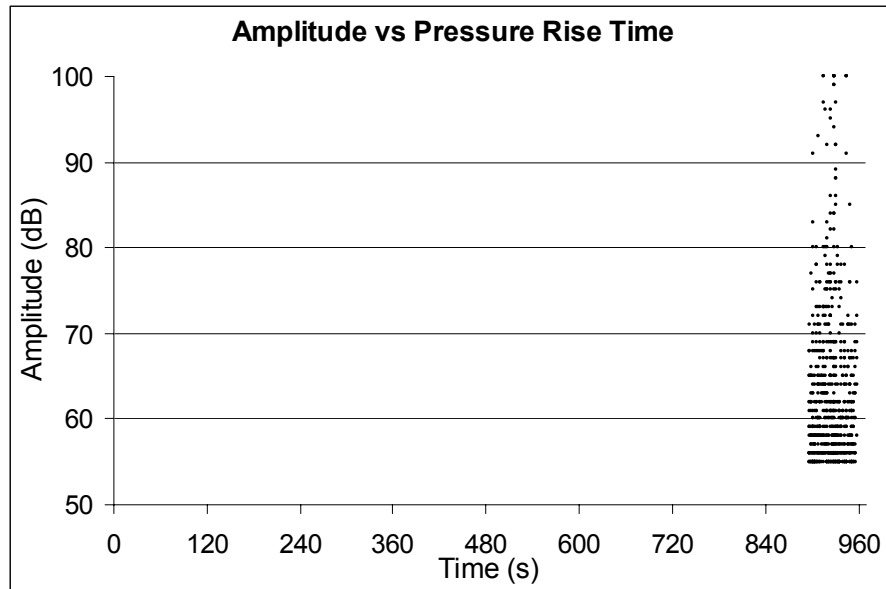
Finally, the results for the third pressurization are quite similar, as shown by the next set of graphs. They show an important friction noise at the beginning of the pressurization, and hardly any attenuation at constant pressure. The cylinder is damaged. The felicity ratio is 0.07, which is very low. The plot of amplitude corresponds exactly to that analysis, displaying an important number of hits at the beginning and then, several hits of very high amplitude at the highest pressure.

The attenuation between the first and the third test is important. The number of hits went from 25948 to 4326. Nevertheless, it is still obvious in the third test that the cylinder is damaged and should not be used in service anymore. The felicity ratio and the shape of the curves are clearly sufficient, and proved to be reliable indicators of the damage.

Generally, the number of hits for the second sensor is more important than for the first sensor for each inspection. It is therefore possible to say that the damages are more important on the side of the second sensor. This was confirmed when the cylinder was submitted to a burst test. It failed at 251 bar (3643 psi), on the precise spot of the second impact.
